# SPALLING CONCRETE REPAIR: WHY YOUR BUILDING'S STRUCTURE IS FLAKING AND WHAT TO DO ABOUT IT

Company: [BRS Building Services Sdn Bhd](#) | 18 August, 2024

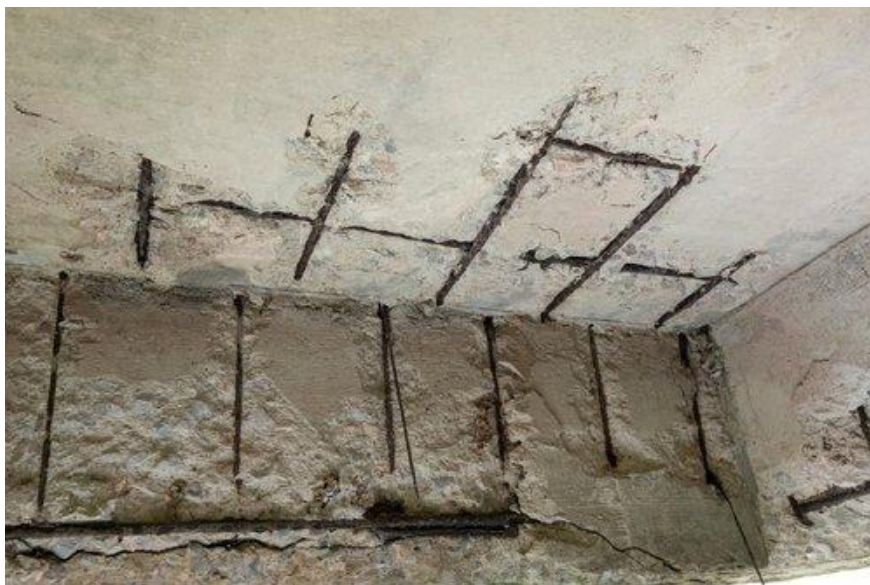
Concrete spalling is a form of deterioration in which the outer surface begins flaking, peeling, or breaking away in small patches. If left unaddressed, this damage can spread and become severe, affecting driveways, walkways, beams, slabs, or even structural elements. The issue typically starts superficially but gradually penetrates deeper, eventually resulting in cracking, exposing coarse aggregates, and revealing corroded internal steel reinforcement (rebar). In Malaysia's tropical environment where heavy rainfall, humidity, and frequent water leakage issues are common, spalling is often linked to waterproofing failures, roof leaking, wall cracks, and moisture intrusion from toilets, balconies, or external walls. These conditions accelerate concrete deterioration and highlight the importance of timely intervention by waterproofing specialists, PU injection contractors, and building repair professionals. The figure below illustrates examples of concrete spalling in a building.

Figure 1: Concrete spalling <sup>[1]</sup>

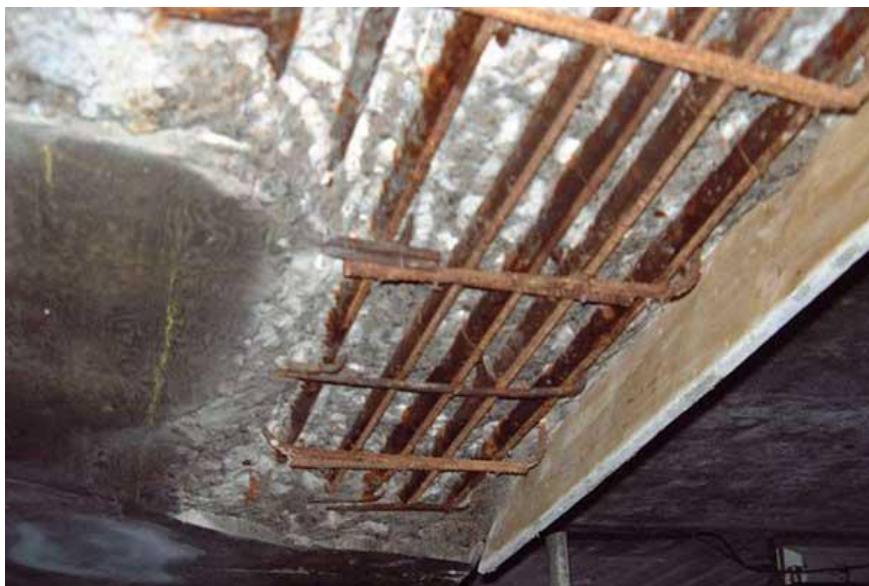
Preventive measures include using high-strength concrete, maintaining low water-cement ratios, ensuring adequate cover thickness (minimum 40mm for moderate exposure), and implementing corrosion inhibitors or protective coatings. In severe cases, methods such as PU injection, crack grouting, or concrete repair systems may be necessary. The figure below shows an example of corroded reinforcement steel.

Figure 2: Corrosion of concrete at rebar <sup>[2]</sup>

Reinforcement steel corrosion is one of the most critical threats to concrete durability, initiating a self-sustaining cycle that seriously weakens the structure. When water and oxygen penetrate concrete through cracks or porous surfaces, an electrochemical reaction begins, turning steel into rust (iron oxide), which expands up to six times its original volume. This expansion generates internal pressure that causes cracking, delamination, and eventually spalling.
